SALINITY MANAGEMENT GUIDELINES

EVERGREEN WATERS ESTATE INCORPORATING GOLDEN GROVE – STAGES 4, 5 & 6 JACKASS FLAT

PREPARED BY SIMONDS DEVELOPMENTS - AUGUST 2011

Groundwater Investigation for Warringal Views P/L

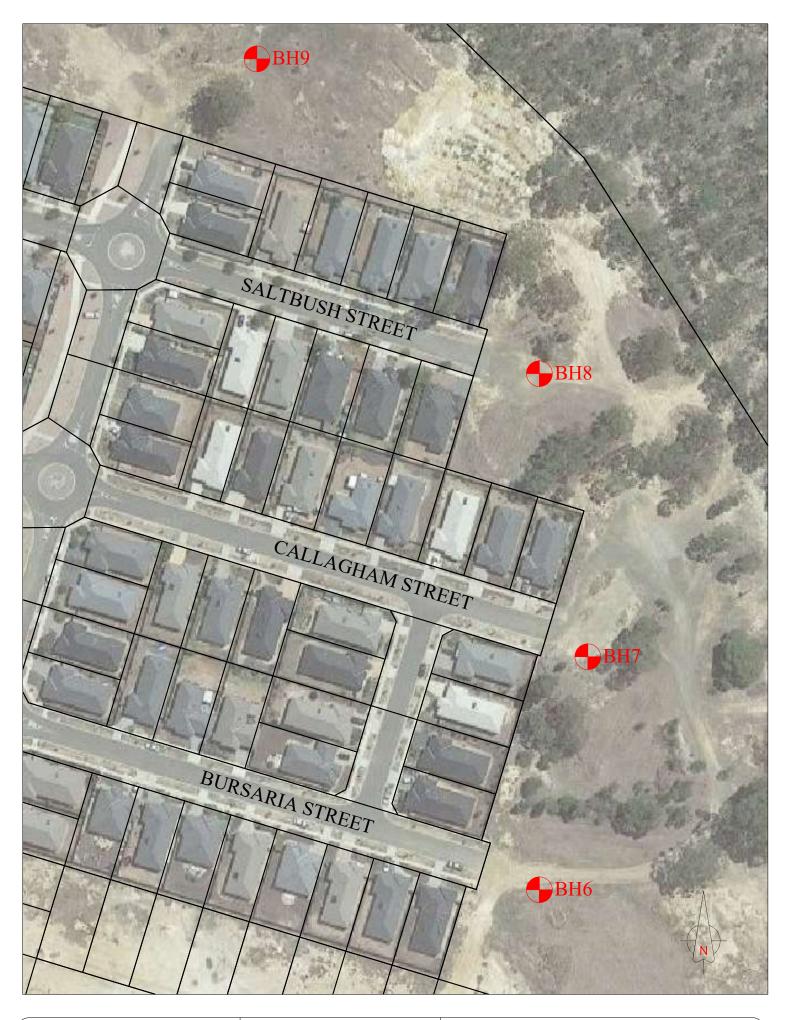
GEOTECHNICAL INVESTIGATION

APPROXIMATE LOCATIONS NOT TO SCALE CLIENT: WARRINGAL VIEWS P/L
PROJECT: GOLDEN GROVE ESTATE,
JACKASS FLATS

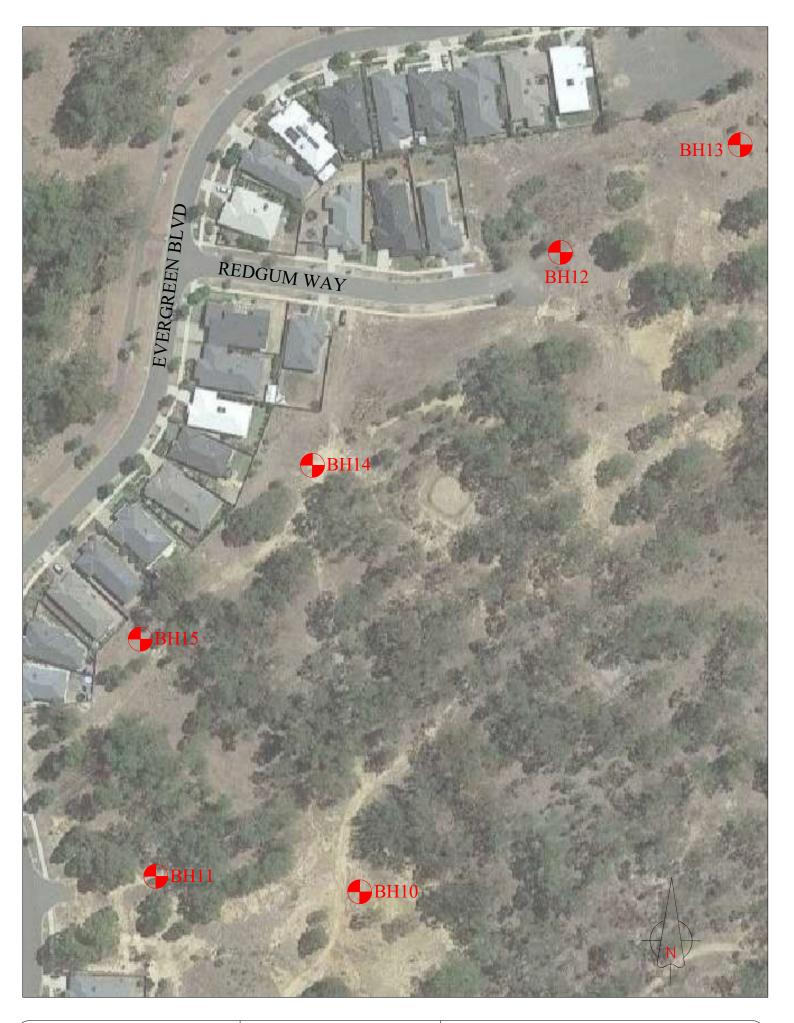
GEOTECHNICAL INVESTIGATION

APPROXIMATE LOCATIONS NOT TO SCALE CLIENT: WARRINGAL VIEWS P/L
PROJECT: GOLDEN GROVE ESTATE,
JACKASS FLATS
