# SALINITY MANAGEMENT GUIDELINES

EVERGREEN WATERS ESTATE  
INCORPORATING  
GOLDEN GROVE – STAGES 4 TO 10  
JACKASS FLAT

PREPARED BY SIMONDS DEVELOPMENTS – AUGUST 2011

Groundwater Investigation  
for  
Warringal Views P/L

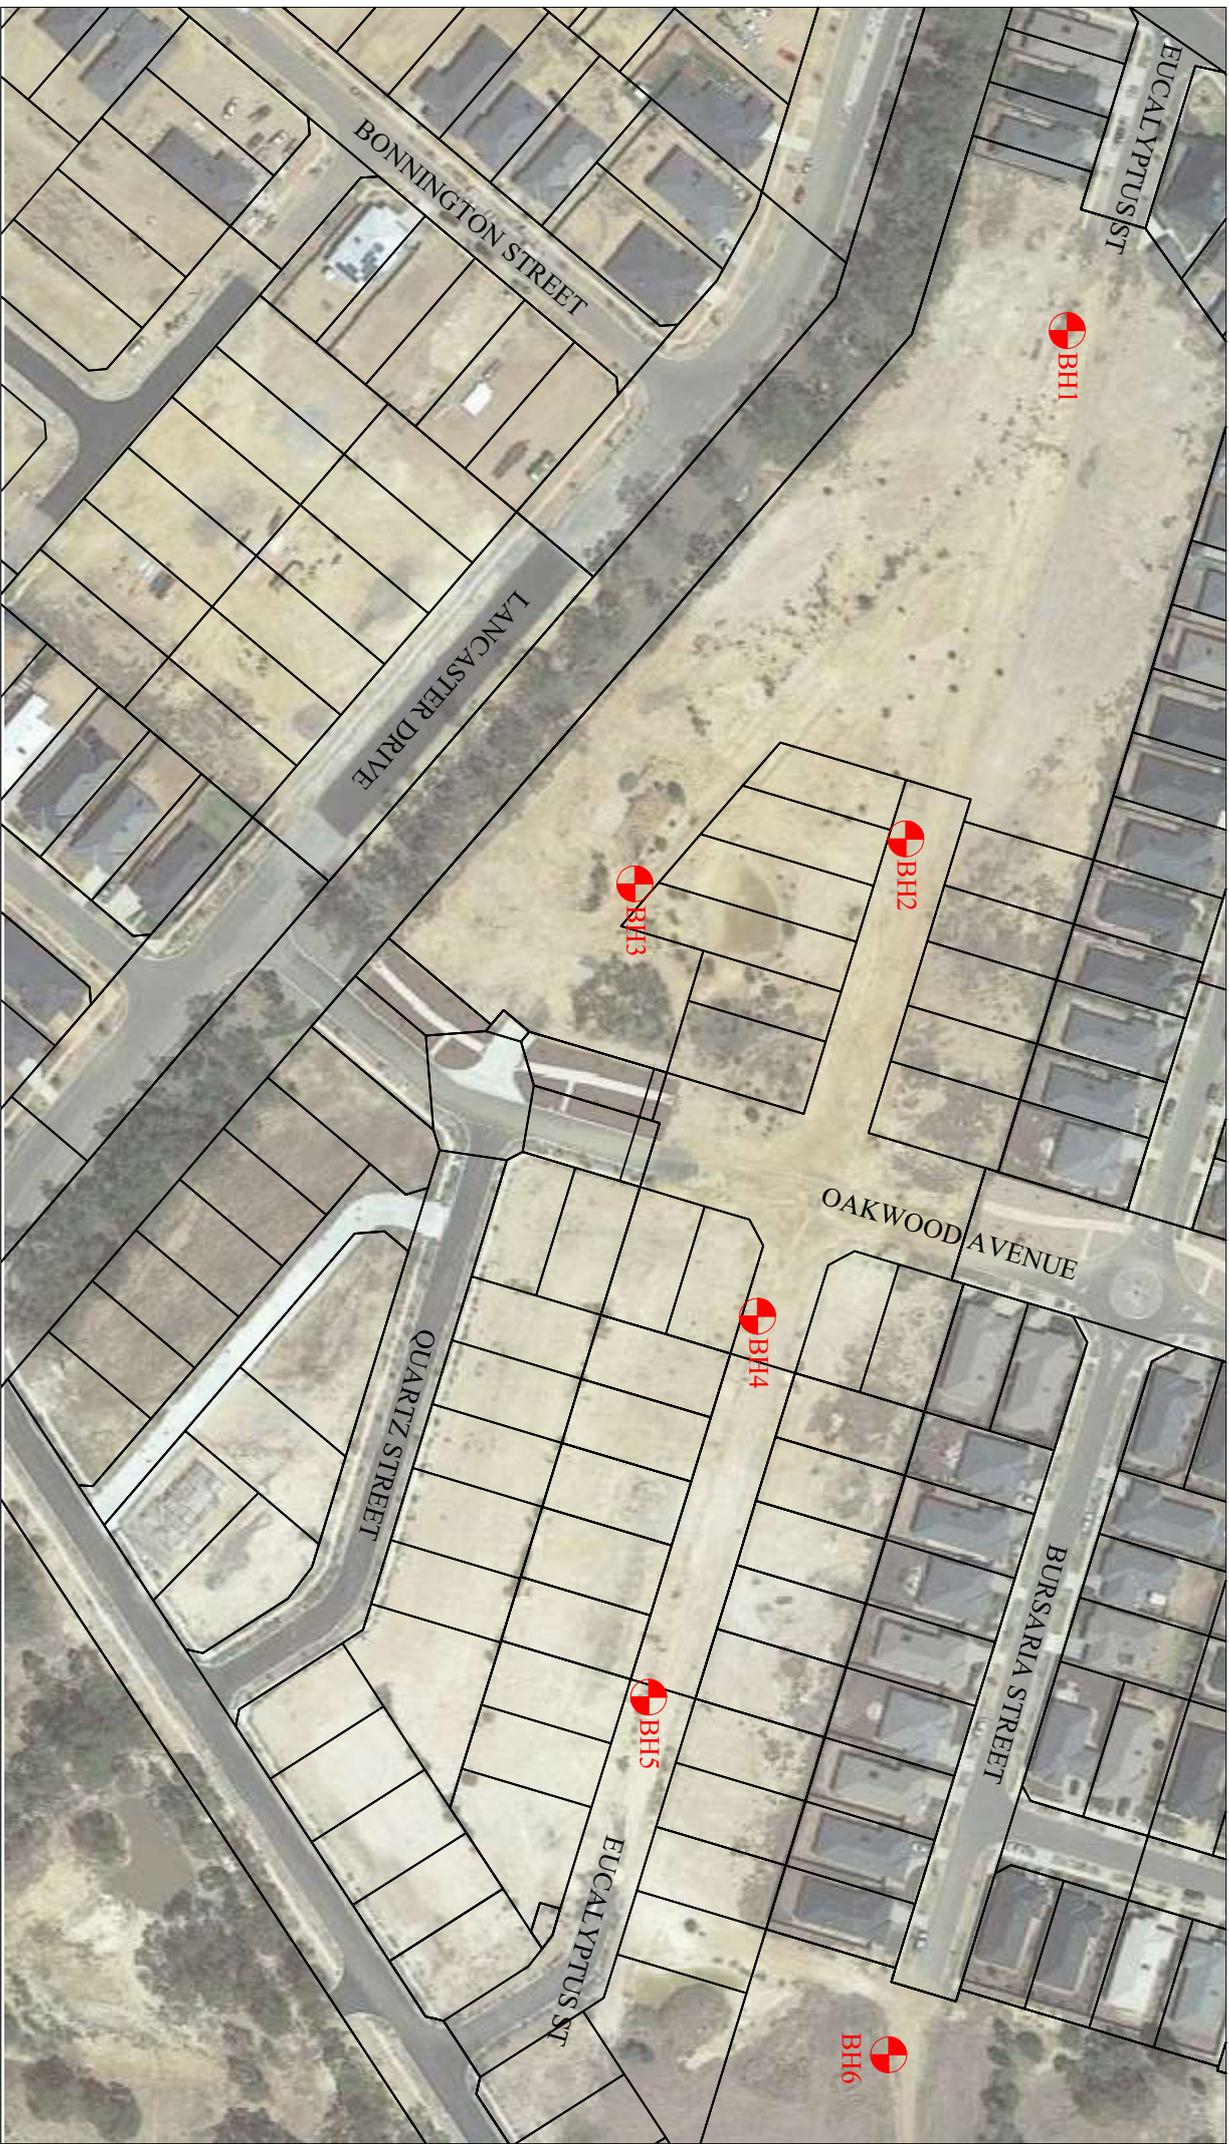
**GEOTECHNICAL  
INVESTIGATION**  
APPROXIMATE LOCATIONS:  
NOT TO SCALE

The field investigation was conducted by a technician under the direction of a Geotechnical Engineer, who logged the subsurface profile. No groundwater was detected in the 15 boreholes, with relatively dry soil conditions experienced throughout the investigation. Borehole 8 was drilled to depth of 2.0m before refusal on medium strength extremely weathered siltstone. The engineering logs are included in the Appendix with their locations shown on the enclosed site plan.

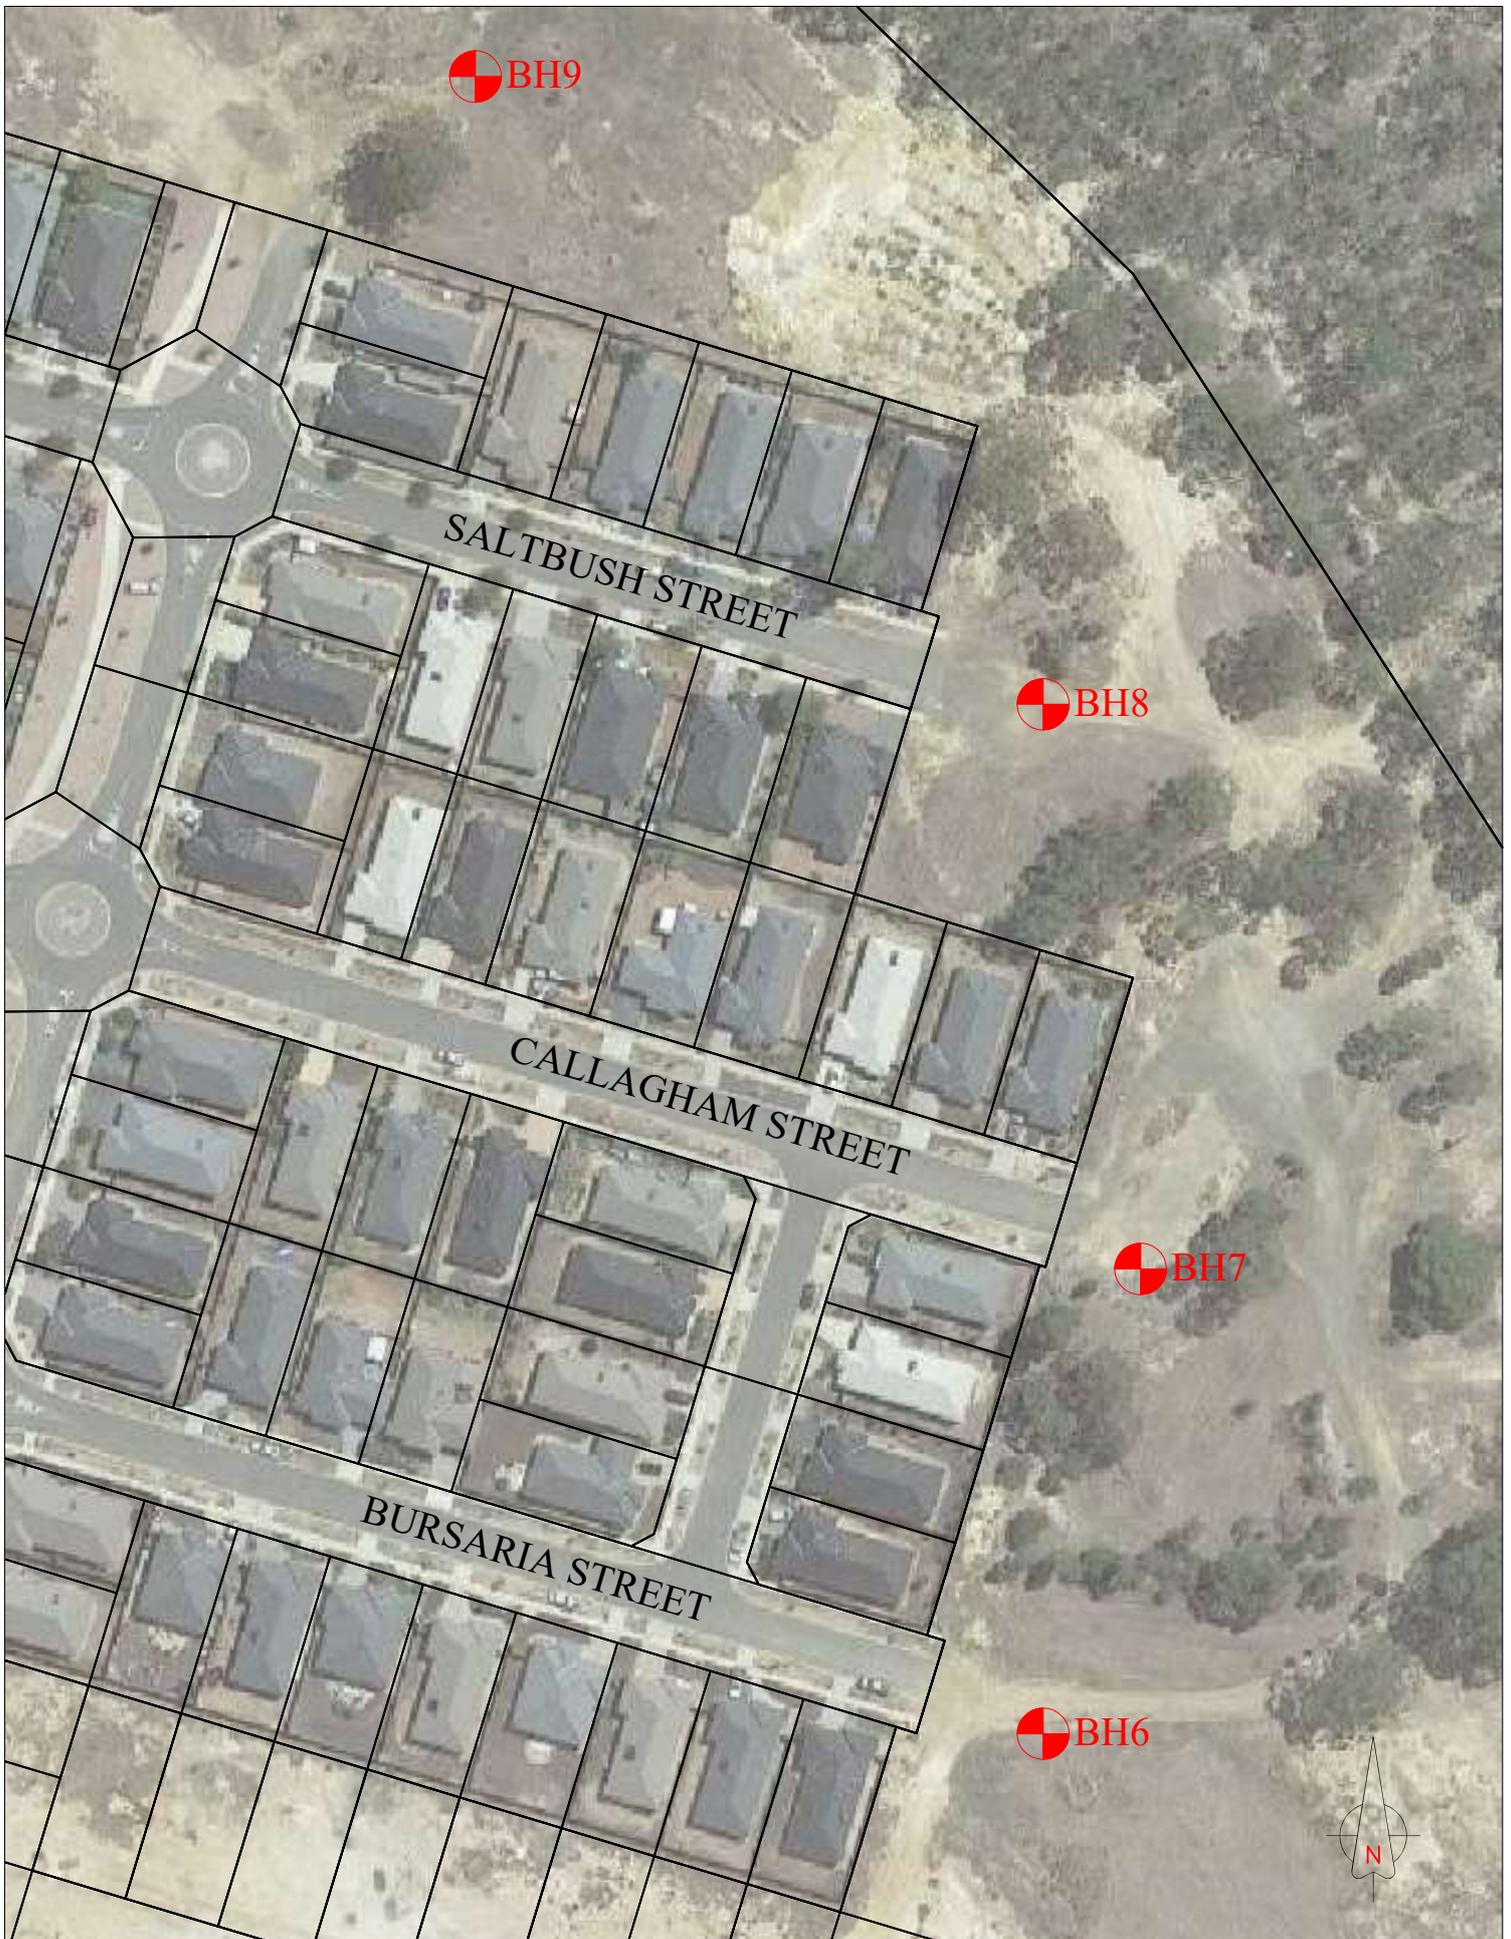
**GEOTECHNICAL INVESTIGATION**

BH9

BH8

BH7

BH6

- ▶ Stage 4 – Borehole 6 (BH6)
- ▶ Stage 5 – Borehole 7 (BH7)
- ▶ Stage 6 – Borehole 8 (BH8)
- ▶ Stage 7 – Borehole 10, 11 (BH10, BH11)
- ▶ Stage 8 – Boreholes 14,15 (BH14, BH15)
- ▶ Stage 9 – Boreholes 12, 13 (BH12,BH13)
- ▶ Stage 8 & 10 – Boreholes BH1,BH2,BH3 (November 2024 Report)

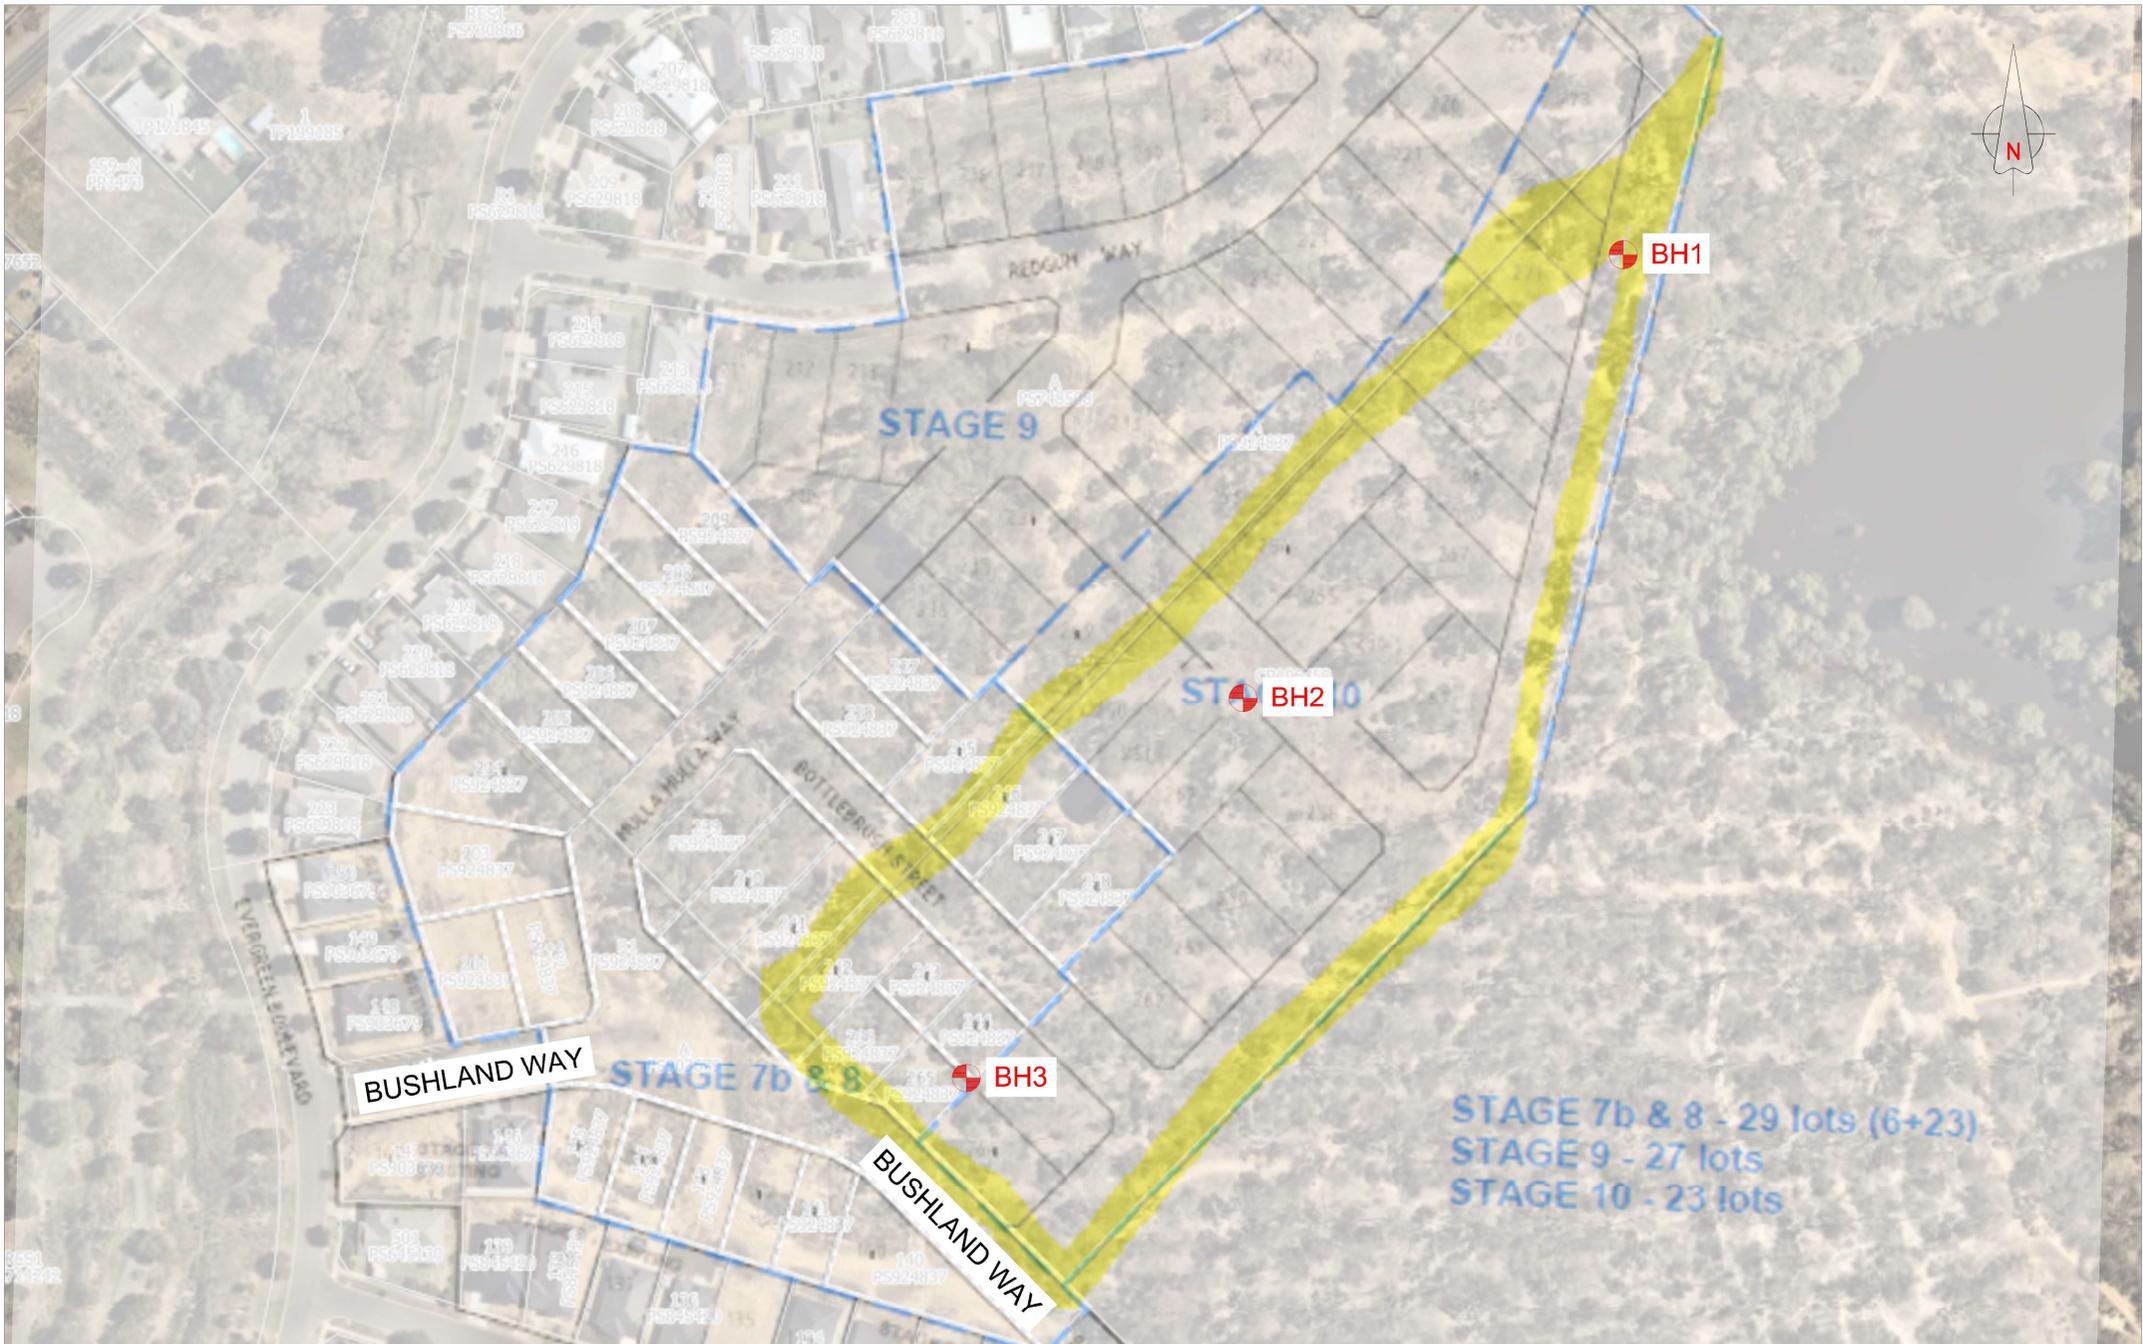
**GEOTECHNICAL INVESTIGATION**  
 APPROXIMATE LOCATIONS  
 NOT TO SCALE

The field investigation was conducted by a technician under the direction of a Geotechnical Engineer, who logged the subsurface profile and determined the testing program. No groundwater was encountered over the 3 boreholes. However, as there was moist material encountered in BH1, a temporary monitoring well was installed. A follow up reading was taken on the 8<sup>th</sup> of November (8 days later) and the hole had not developed any groundwater.
