SALINITY MANAGEMENT GUIDELINES

EVERGREEN WATERS ESTATE
INCORPORATING
GOLDEN GROVE – STAGE 3
JACKASS FLAT

PREPARED BY SIMONDS DEVELOPMENTS – AUGUST 2011

Report 20C 0155
March, 2020

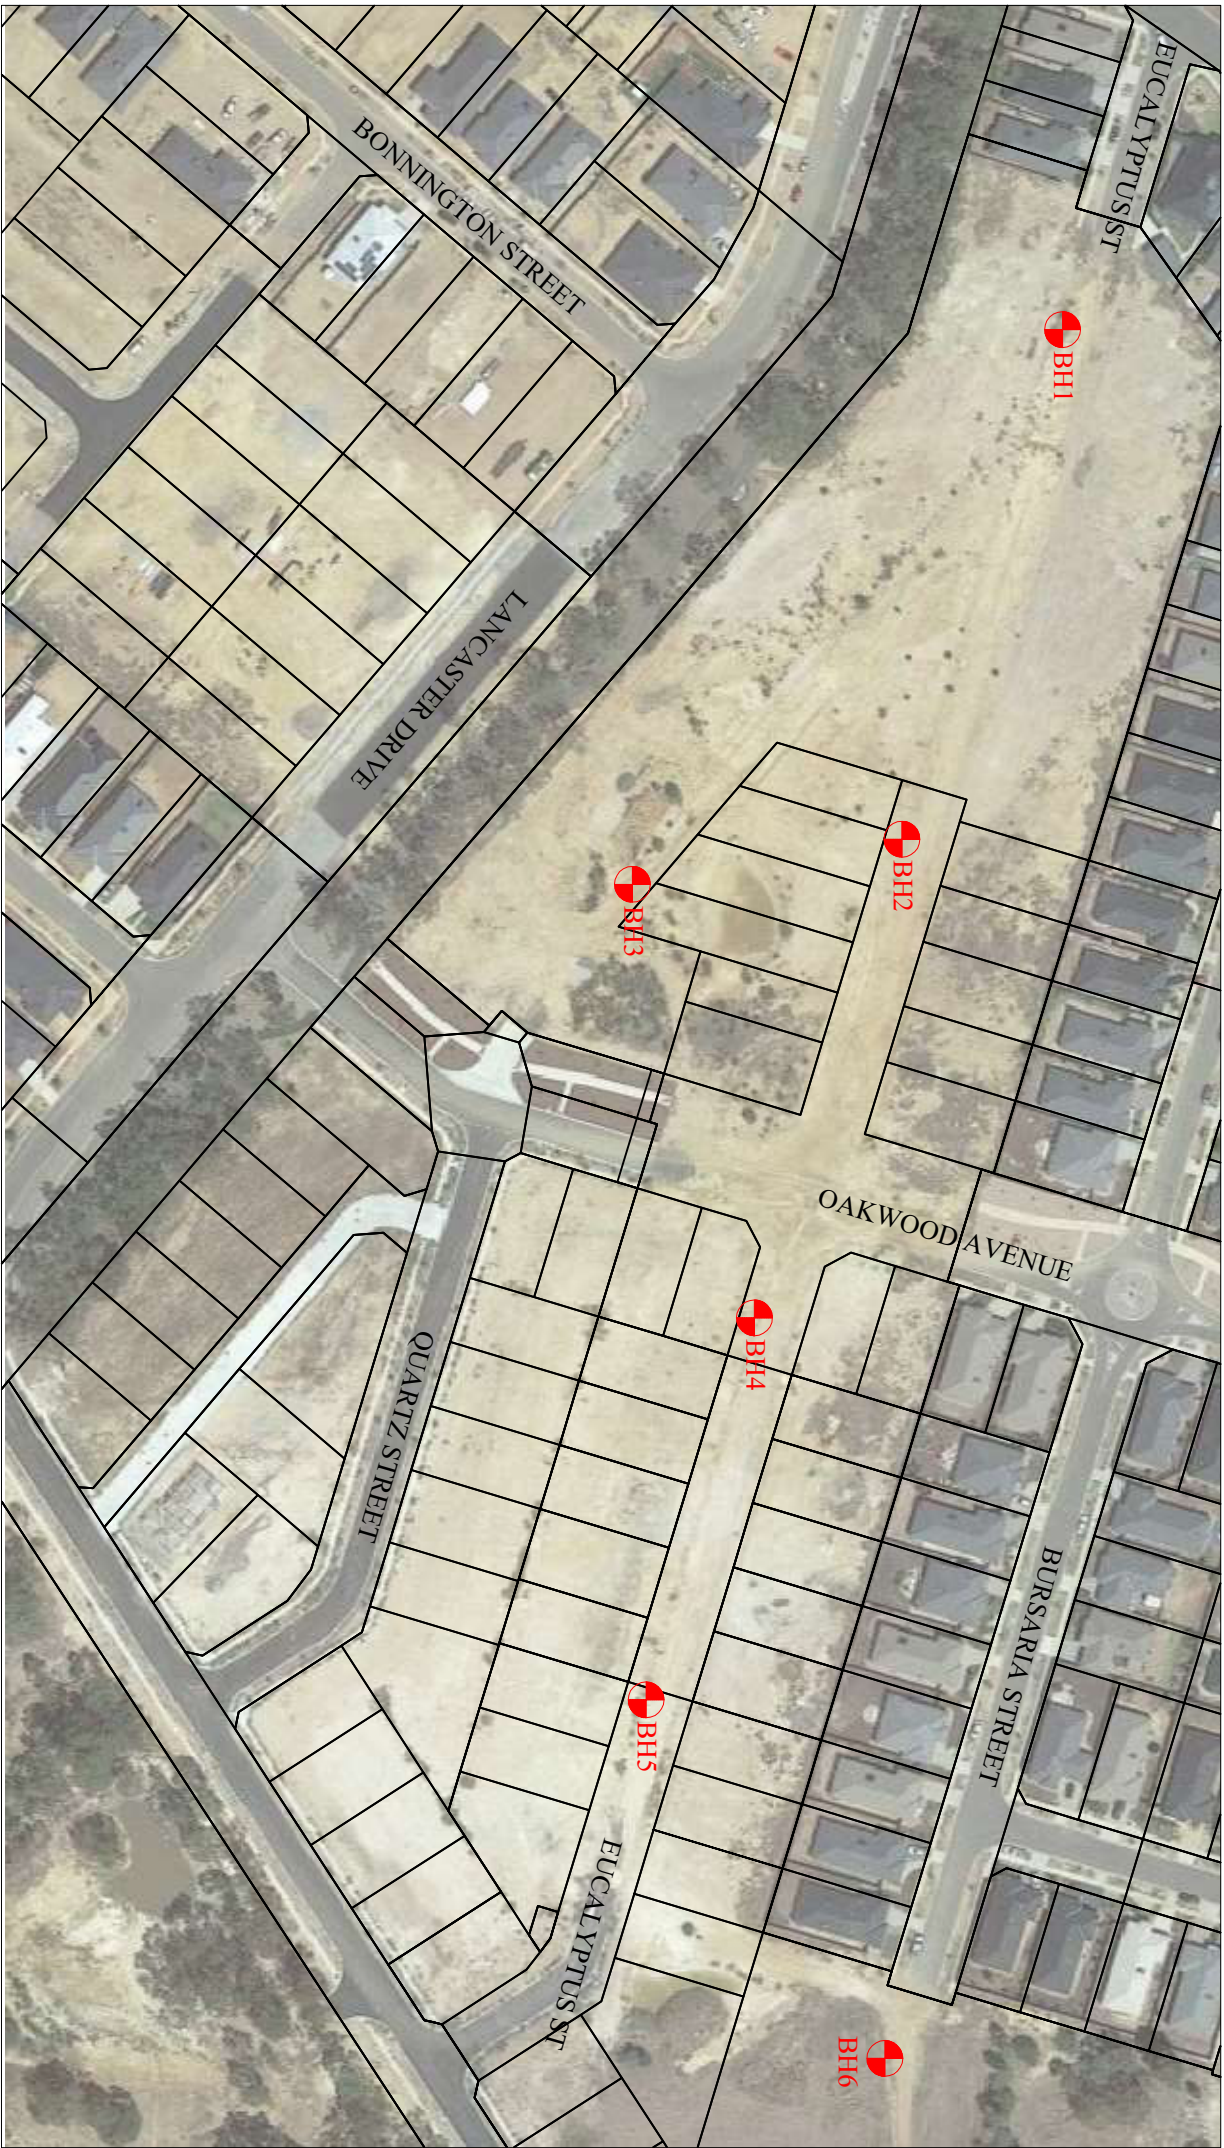
GEOTECHNICAL INVESTIGATION
APPROXIMATE LOCATIONS:
NOT TO SCALE

The field investigation was conducted by a technician under the direction of a Geotechnical Engineer, who logged the subsurface profile. No groundwater was detected in the 15 boreholes, with relatively dry soil conditions experienced throughout the investigation. Borehole 8 was drilled to depth of 2.0m before refusal on medium strength extremely weathered siltstone. The engineering logs are included in the Appendix with their locations shown on the enclosed site plan.

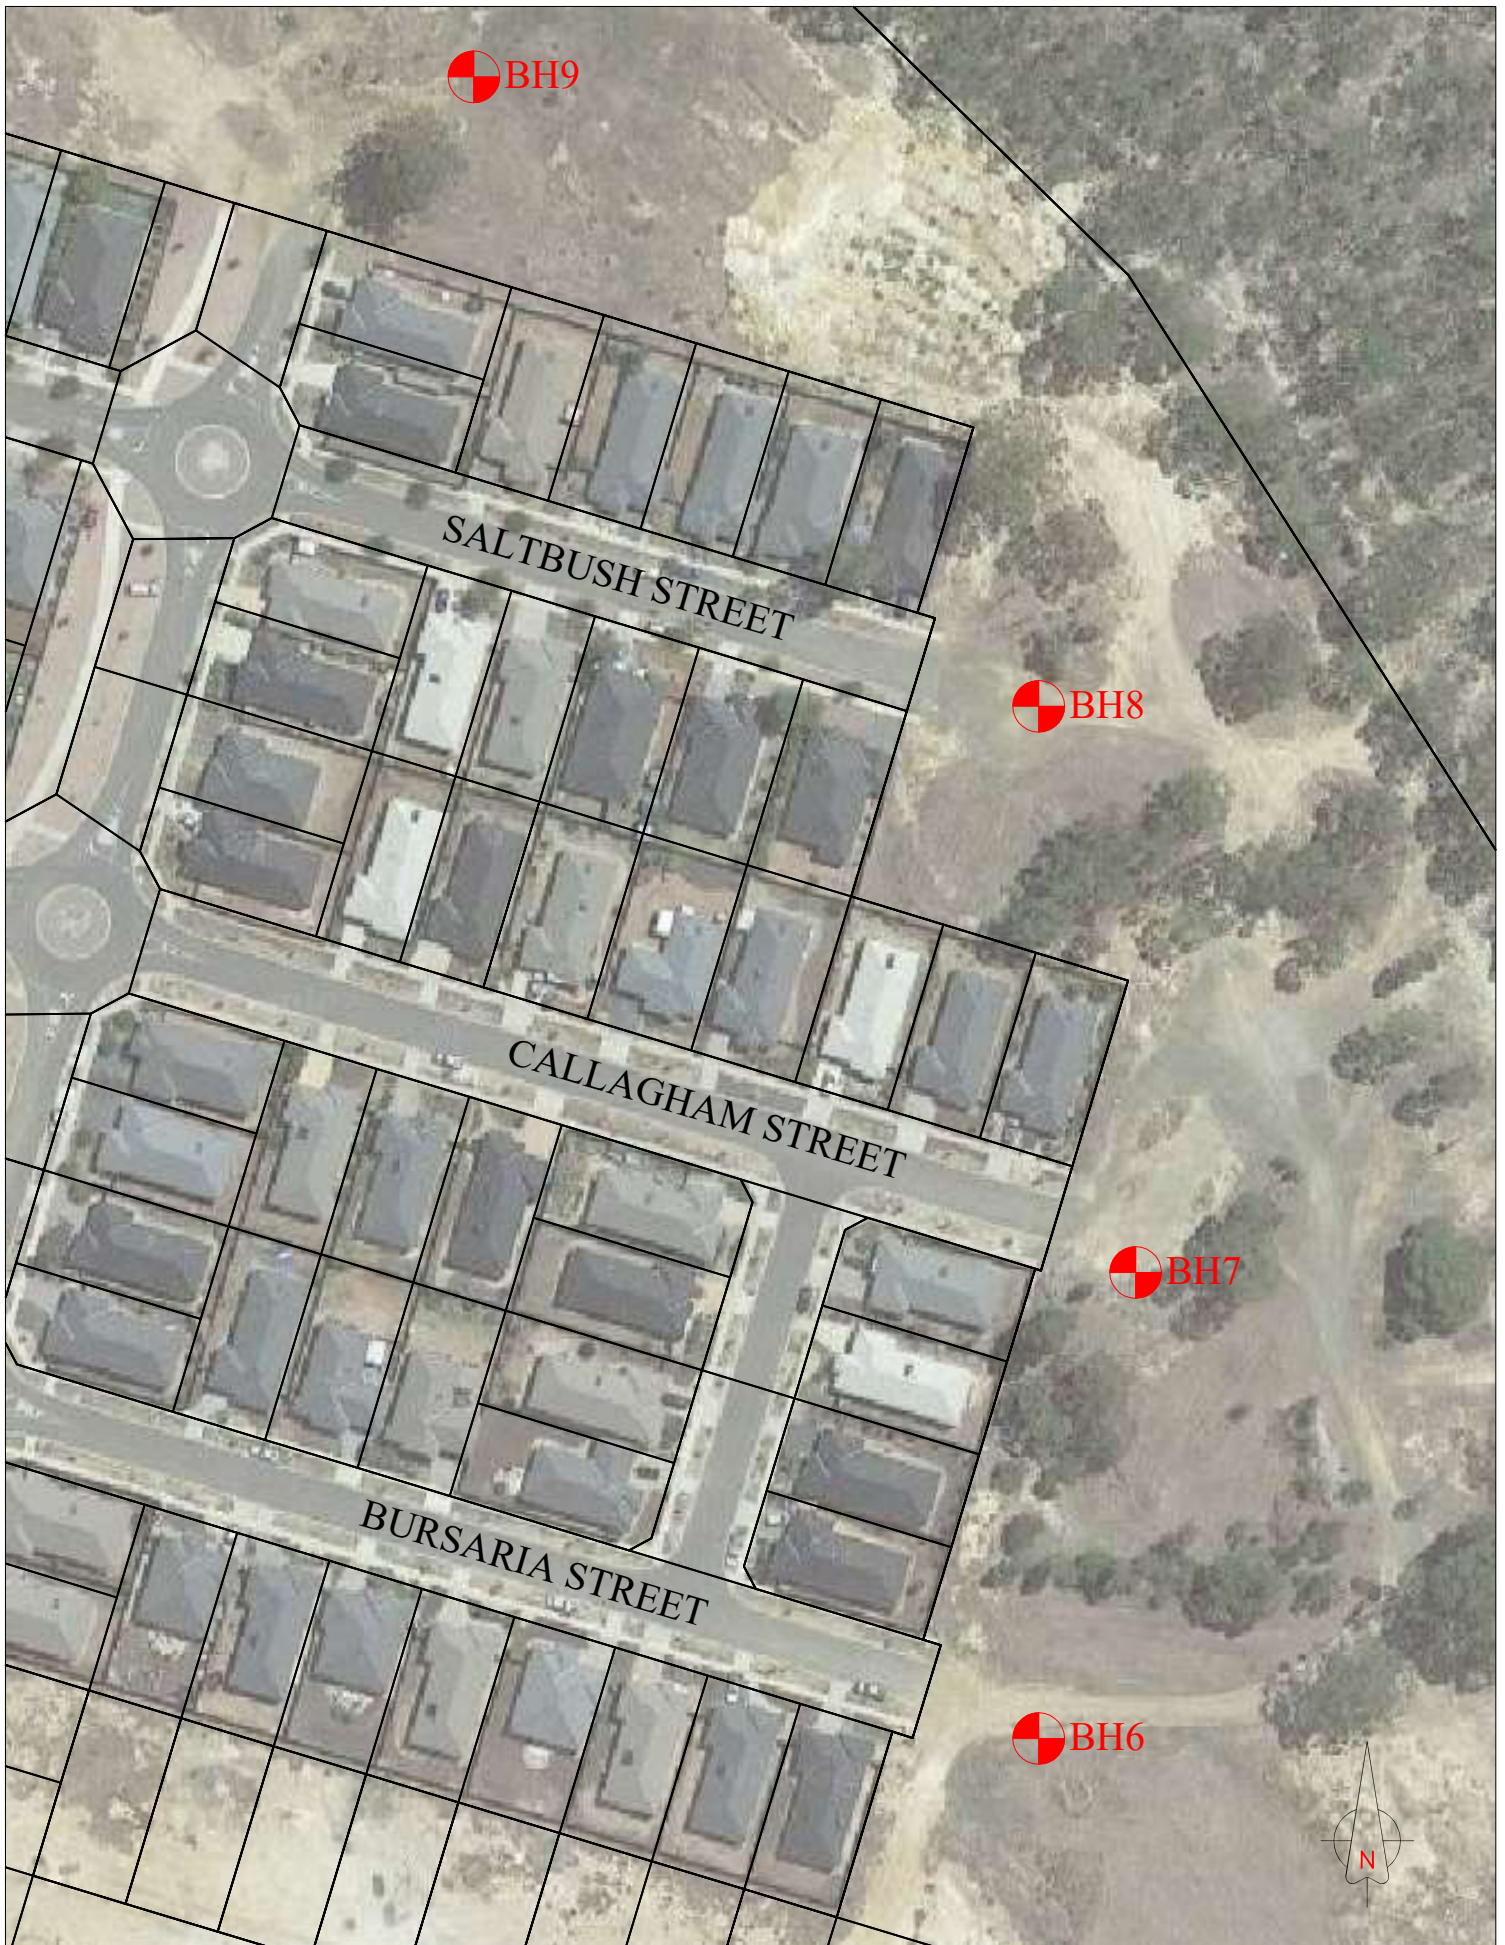
GEOTECHNICAL INVESTIGATION

BH9

BH8

BH7

BH6
